Manhole Inspection Summary

Manhole # S25G__016MH

Insp Date: **8/31/07 10:03 AM**

Location Address: **19 FAYETTE-FAIRMOUNT**

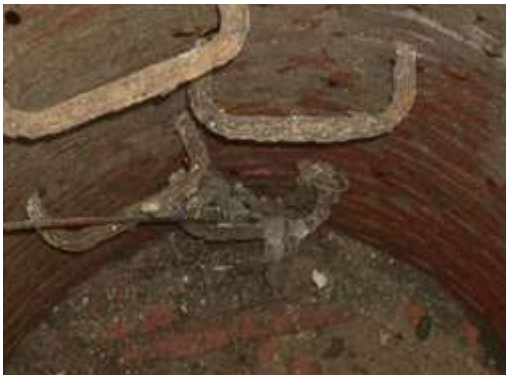
Defect 3

Surcharge ☒ **Evidence Of Surcharge** Depth: **2** (ft.) ☐ Active Surcharge Present

SURCHARGE EVIDENCE ON THE STEPS

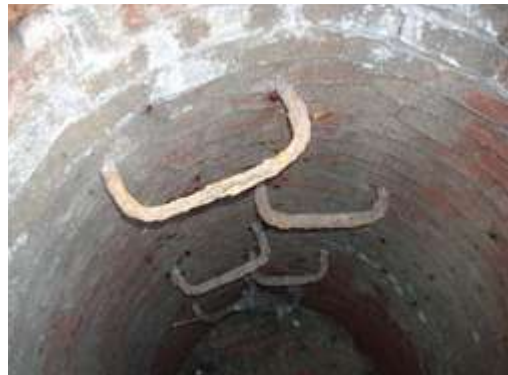
Defect 2

Steps Count: **6** Missing: **0** ☒ **Corroded**

CORRODED STEPS

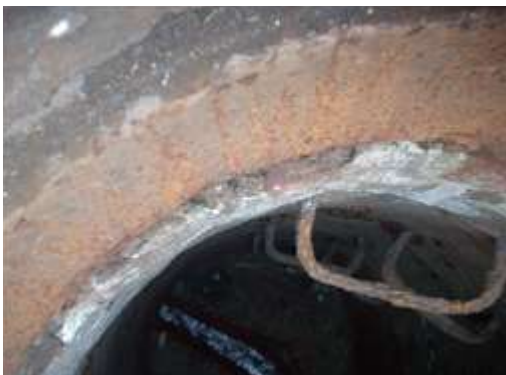
Defect 1

Frame Offset: **1** (in.) Condition: ☒ Sound ☐ Cracked ☐ Leaks

FRAME OFFSET

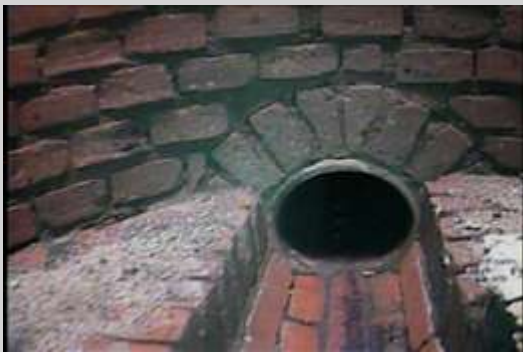
12 O'Clock Outflow

8 in. Circular Gravity Sewer
Pipe Out @ 12 O'Clock

Pipe Height: **8.4** (in.) Rod and Bar (Angled)
Pipe Material: **Clay** ☐ Pipe Lined
Invert Depth: **10.80** (ft.) Flow Characteristics: **Slow**
Deposits: ☒ None ☐ Mud ☐ Sludge ☐ Debris ☐ Grease
Silt Depth: (in.) Deposits Extent:
Infiltration: **None** Pipe Seal Cond: **Sound**

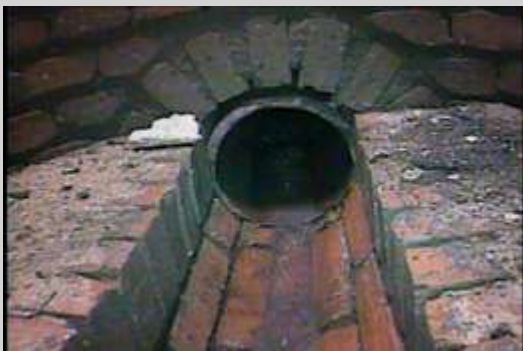
4 O'Clock Inflow

8 in. Circular Gravity Sewer
Pipe In @ 4 O'Clock

Pipe Height: **8.4** (in.) Rod and Bar (Angled)
Pipe Material: **Clay** ☐ Pipe Lined
Invert Depth: **10.72** (ft.) Flow Characteristics: **Slow**
Deposits: ☒ None ☐ Mud ☐ Sludge ☐ Debris ☐ Grease
Silt Depth: (in.) Deposits Extent:
Infiltration: **Evidence** Pipe Seal Cond: **Broken**
